# PROPERTY INSPECTION REPORT

**CLIENT NAME:** Mr. & Mrs. Home Buyer.  
**DATE OF INSPECTION:** January 1, 2015.

**INSPECTION SITE:** 123 Any Street  
San Jose, CA 95123.

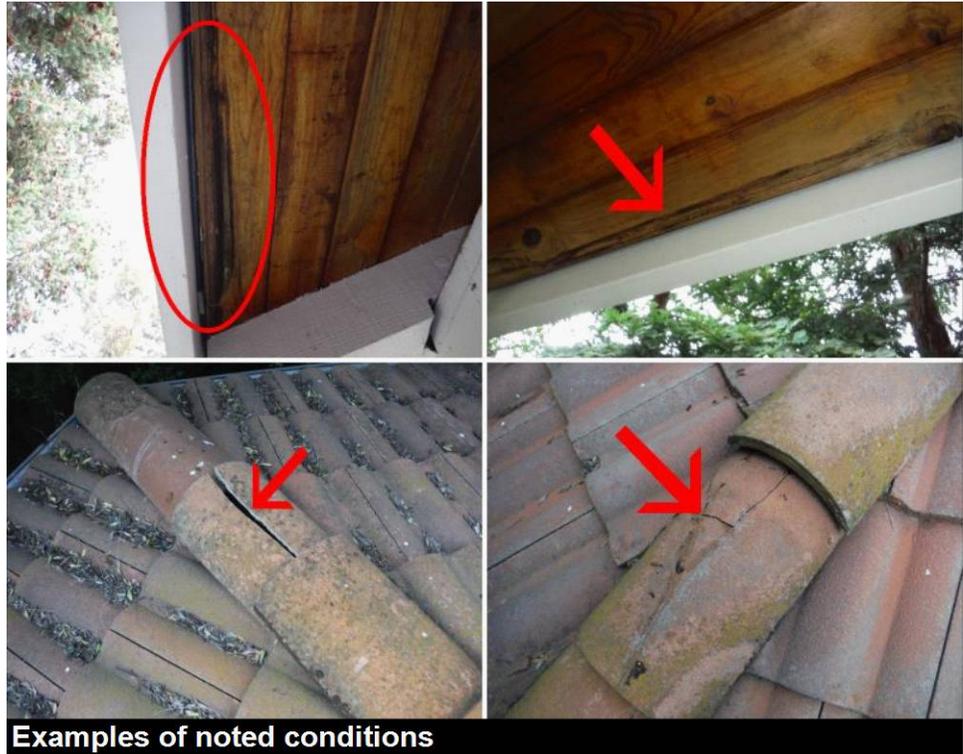
**CONDITION:** General condition appears satisfactory. Moisture stains/damage was viewed at cover and/or structure. Conditions should be monitored, repair/replacement or adjustments may be necessary.  
A number of damaged or loose tiles noted. Repair/Replacement needed. Recommend evaluation and repair by a qualified licensed roofing contractor. Trees are touching or overhanging the roof. Recommend trimming to prevent damage to roof or structure. Recommend clearing all debris from roof surface to prevent damage.

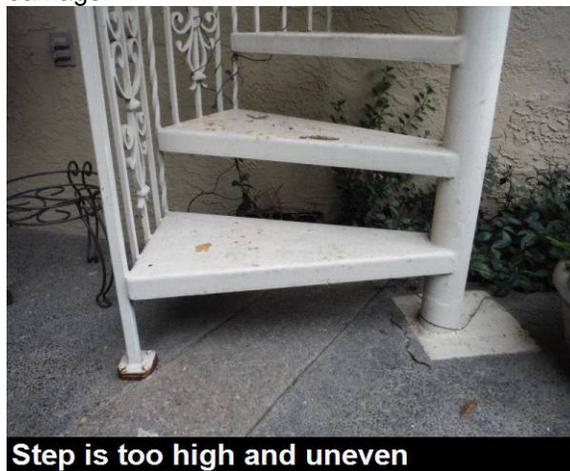
**LOCATION:** Rear balcony.  
**TYPE:** Wrought iron spiral staircase.  
**CONDITION:** Uneven or improper rise on steps. This is a potential tripping hazard, correction is needed for safety. Step rise appears to be too high. This is a possible trip/safety hazard, recommend repairs for safety. Low overhead clearance at balcony structure. Potentially HAZARDOUS conditions exist. Recommend further evaluation and repair by a qualified licensed contractor.  
Stair handrail appears to be in serviceable condition. Rusting visible at a number of areas on the metal staircase, recommend cleaning and painting to prevent further damage.

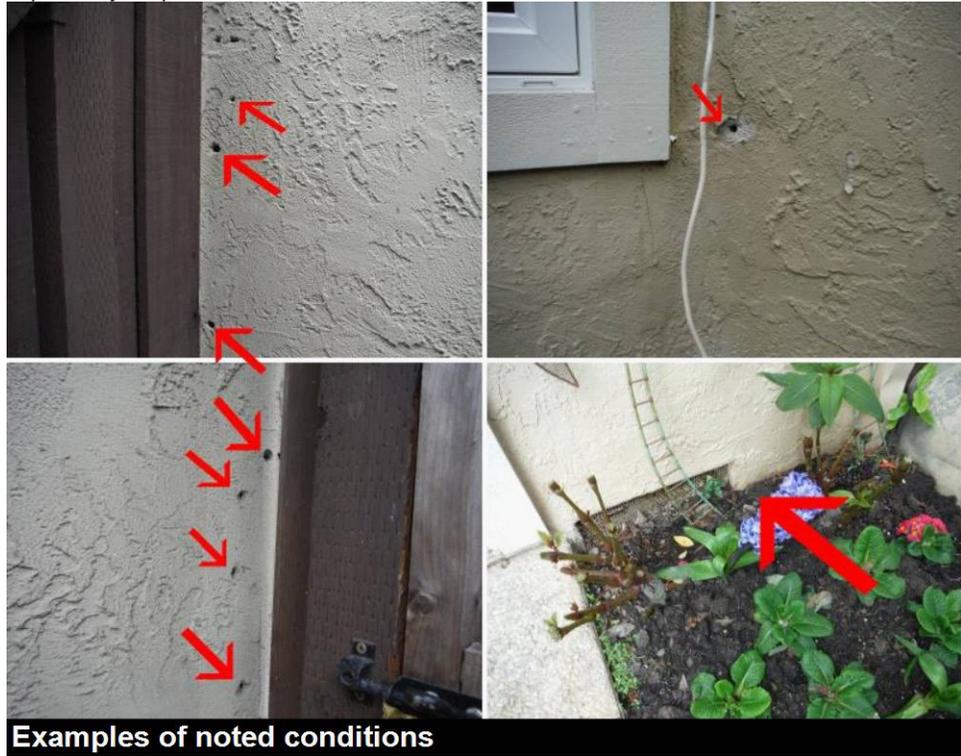
The general condition appears to be serviceable/functional. Holes/openings viewed at exterior walls at a number of areas. Recommend sealing all cracks, voids and openings in exterior wall materials to prevent moisture intrusion and damage. Soil was in direct contact with the exterior wall siding at the rear side. This may negatively effect the exterior walls ability to properly drain moisture and also allows a direct path for wood destroying pests/organisms. Recommend grading away at least six inches below exterior siding for proper drainage. Recommend further evaluation and repairs by a qualified, licensed contractor.

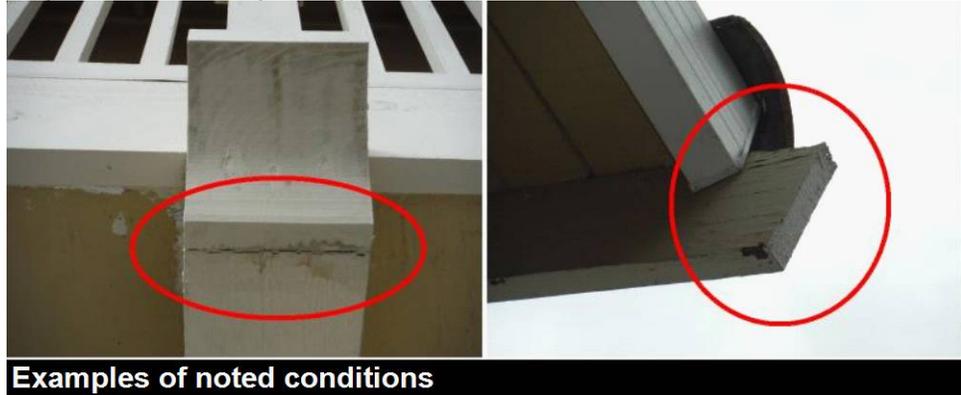
**Examples of noted conditions**

The general condition of the exterior eaves and trim appears to be functional. Moisture stains and/or damage noted at the wood exterior trim and eaves at various areas. Refer to qualified structural pest report for further information.

Recommend caulking or properly sealing all separations in exterior trim to prevent moisture intrusion and moisture damage.

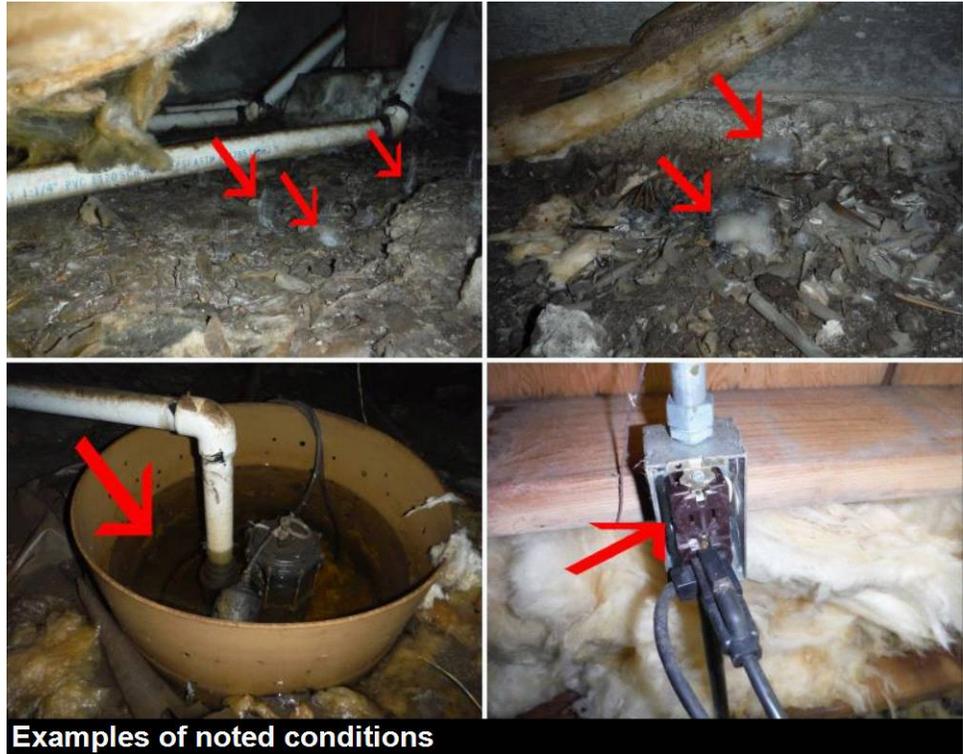
Moisture present, throughout the crawlspace area. Excessive moisture and standing water in crawlspace at the northern side. Further evaluation by a qualified site drainage expert and/or Geo-technical Engineer is recommended. No vapor barrier is present in the crawlspace. May be due to poor site drainage. It is important to monitor the site drainage around the entire house during wet weather to ensure proper flow away from the foundation. Or due to poor cross ventilation or inadequate ventilation openings. A qualified licensed contractor should be consulted for further information.

Evidence of microbial growth in the crawlspace. Growth of this nature commonly occurs in areas that are subject to moisture intrusion, leakage and/or inadequate ventilation. It is recommended that further evaluation by a State Certified Industrial Hygienist confirm the type of growth and what remedial action should be taken for its permanent removal from the property.

Four sump pumps are installed in the crawlspace area. Pumps are NOT operational. Missing cover plate at sump pump receptacle in the crawlspace. Unable to verify proper Ground Fault Circuit Interrupter 'GFCI' outlet at sump pump motor, a qualified, licensed electrician should be consulted to ensure safe conditions. Sump drain termination points are at the south side, recommend routing away from the foundation.

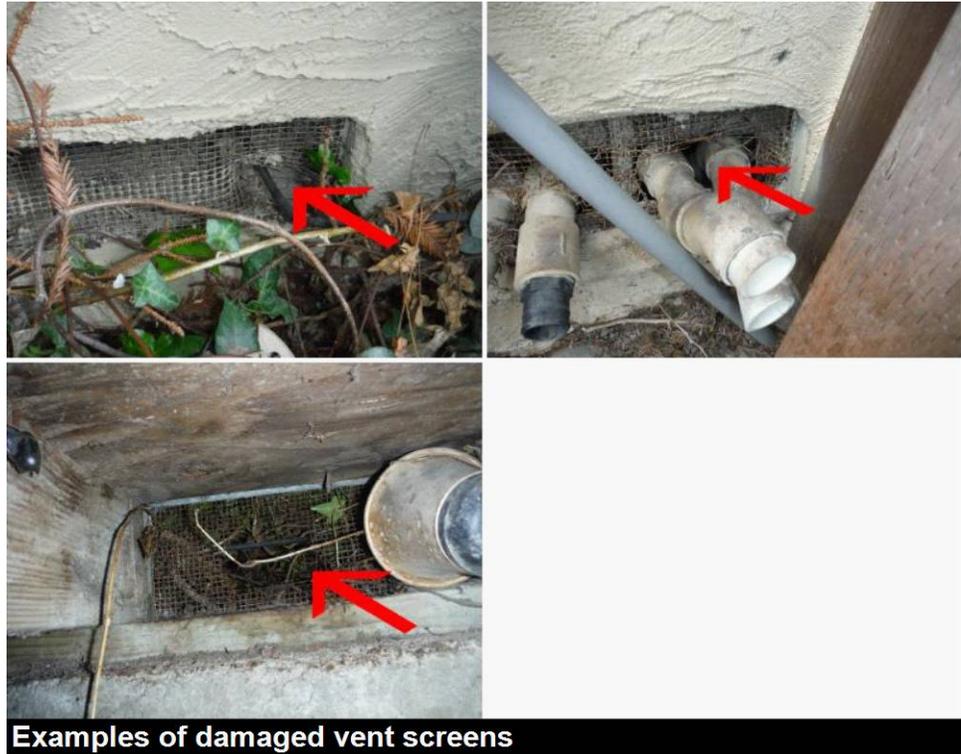
A number of crawlspace vents were blocked by sub floor insulation and foliage, recommend adjustment/repair for proper air flow in crawlspace. Unable to verify proper cross ventilation in crawlspace area

A number of crawlspace screens were damaged, recommend repair/replacement as needed to prevent pest intrusion. Rear vent screen/openings are at grade level. Recommend repairs to prevent moisture intrusion into crawlspace.

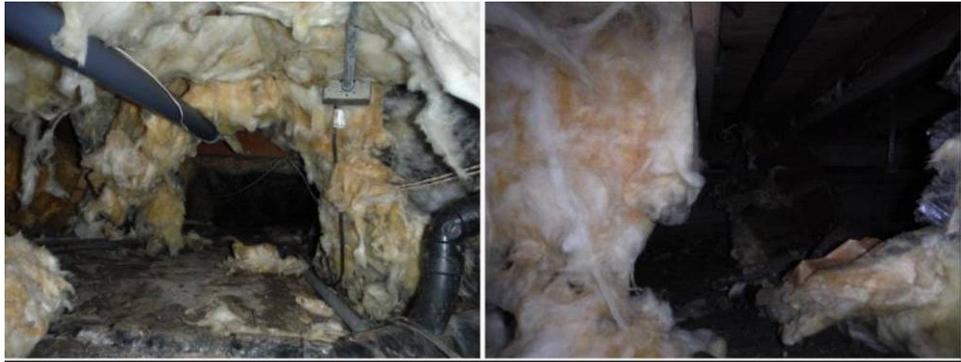
**FRAMING DESCRIPTION:** Plywood subfloor. Wood floor joists. Wood support beams/girders.  
**FLOOR AND JOIST FRAMING CONDITION:** The general condition of the viewable portions of the subfloor and floor framing appears to be in functional/serviceable condition.  
**SUBFLOOR INSULATION:** Insulation was loose and damaged in a number of areas, recommend properly securing all insulation for proper performance. Recommend further evaluation and repairs by a qualified, insulation contractor.

**Loose/damage insulation**

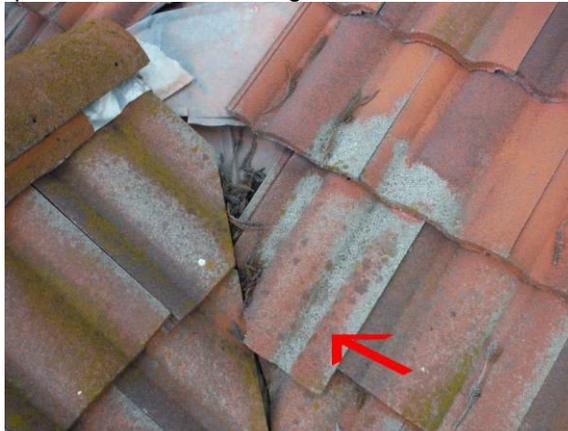
<b>STYLE:</b>	Sloped roof.
<b>TYPE:</b>	Concrete tile.
<b>NUMBER OF LAYERS:</b>	Appears to be a single layers of roofing materials installed.
<b>ROOF ACCESS:</b>	Walked on roof surface.
<b>ROOF CONDITION:</b>	The visible portions of the roof appears to be within useful life and functioning as intended. TYPICAL MAINTENANCE RECOMMENDED. This usually consists of repair/replacement of damaged or loose tiles. This maintenance should help insure the weather tightness of the building and should be performed on a regular basis. Evidence of prior repairs noted at a number of areas. No fasteners for roof tiles or underlayment visible from the attic area. Current industry standards require a fastener for each tile. Roof may precede current standard. A qualified, licensed roofing contractor should be contacted for further evaluation.

**Repair loose tiles**

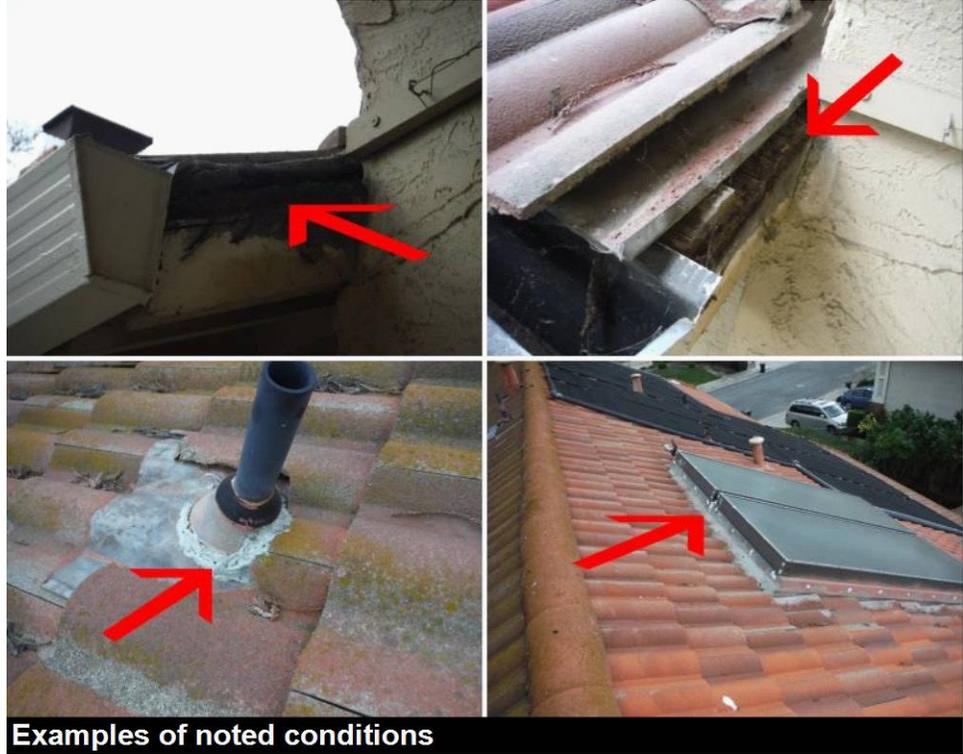
The general condition of the exposed flashing, vent caps and pipe jacks appears functional. Improper mastic used at roof flashing at a number of areas and appears to be a temporary fix. No visible flashing installed at the front rake. A licensed roofing contractor should be called to make further evaluation and repairs as needed. Solar water heater panels appear to be greater than 30 inches in width, a cricket type flashing is recommended/required to help water drainage around chimney at roof. Recommend evaluation and repair by a qualified, licensed roofing contractor.

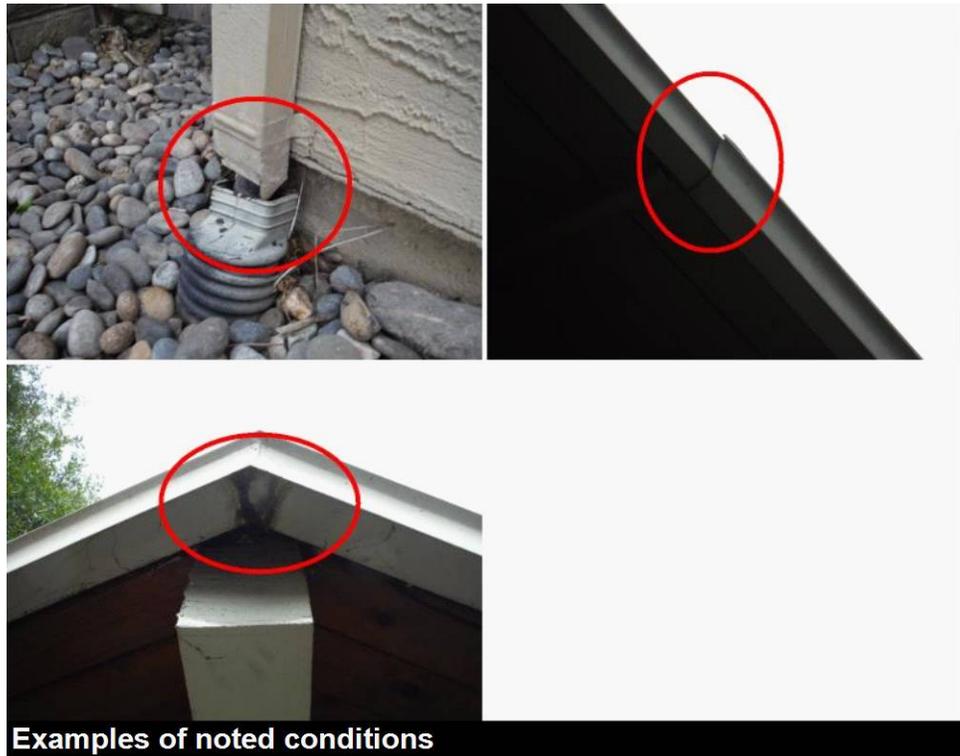
The general condition of the gutter system appears functional. Wear and deterioration noted at various areas. Separations were visible at gutter seams. Evidence of leakage at gutter/downspout seams. Loose downspout connections to subsurface drains at a number of areas. Repair as needed.

Gutters were filled with debris at the time of the inspection. Recommend cleaning all gutters and downspouts. This maintenance should be done on a regular basis to allow proper drainage.

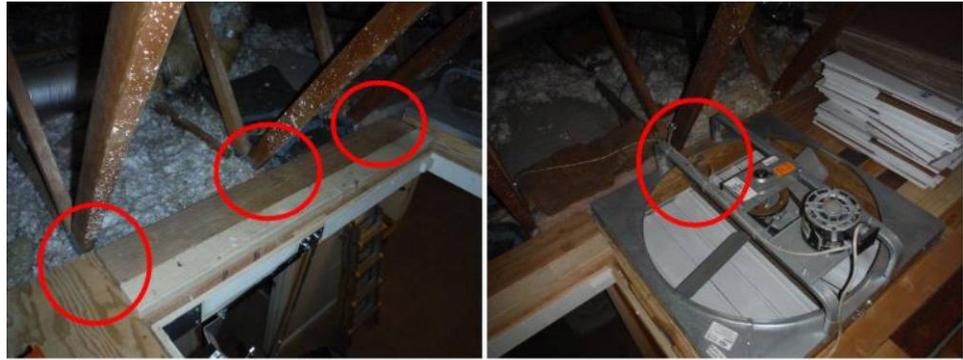
- ACCESS LOCATION:** Upper hallway ceiling and master bedroom closet ceiling.
- FRAMING** Engineered pre-manufactured truss framing. Skip sheathing.
- DESCRIPTION:**
- ACCESSIBILITY** The attic was accessible and entered at the upper hallway access at the time of the inspection.
- ACCESS CONDITION:** Attic access pull down ladder was in functional condition.
- ATTIC CONDITION:** Truss framing is damaged or altered at the pull-down ladder and the whole house fan assembly. This may affect the structural integrity of the framing system. No engineering is performed during this inspection. Further evaluation by a qualified, registered Professional Engineer is needed to determine structural integrity.

**Altered truss framing**

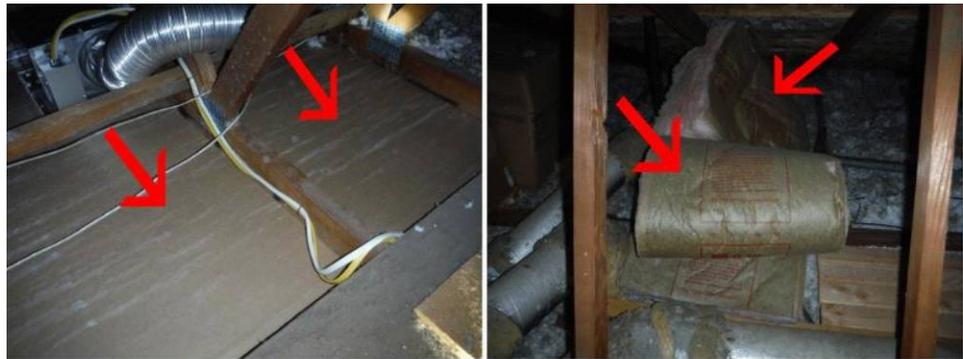
**Examples of noted conditions**

The visible portions of the attic insulation coverage appears to be adequate. Insulation has been disturbed in some areas and good coverage is no longer present. Insulation is somewhat compacted and the true R-factor at this point in time may be substantially less than that originally installed. Installation of additional insulation is recommended. Fiberglass batt insulation is loose and backing is exposed in some areas. Potentially HAZARDOUS conditions exist. Recommend evaluation and repair by a qualified, insulation contractor.

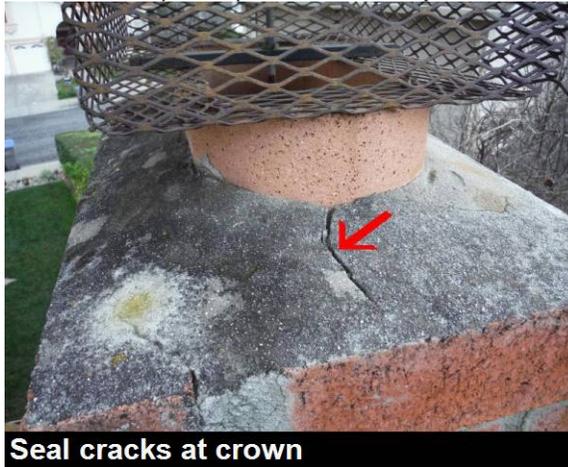
**Seal cracks at crown**

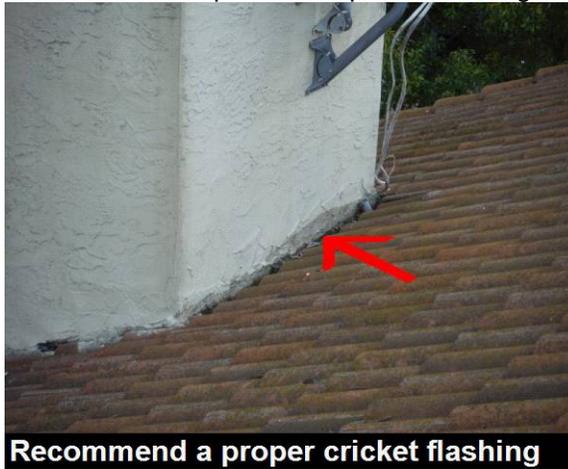
**ADDITIONAL NOTES:** Chimney appears to be greater than 30 inches in width, a cricket type flashing is recommended/required to help water drainage around chimney at roof.

**Recommend a proper cricket flashing**

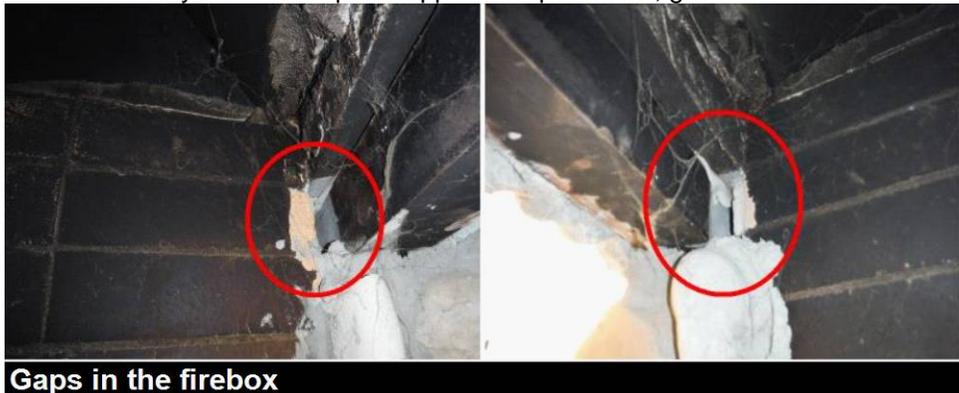
**LOCATION:** Family room.  
**TYPE:** Masonry, gas supplied. Ceramic gas log present.  
**CONDITION:** The general conditions of the visible portions of the fireplace appears to be in functional condition. Gaps/separations at front side of the firebox area. Potentially HAZARDOUS conditions exist. Recommend further evaluation by a qualified, licensed contractor. Damper is operational with signs of wear and deterioration. Recommend the installation of a proper/listed damper clamp to prevent the damper from closing when gas is present for added safety. Gas in fireplace appeared operational, gas valve installed.

**Gaps in the firebox**

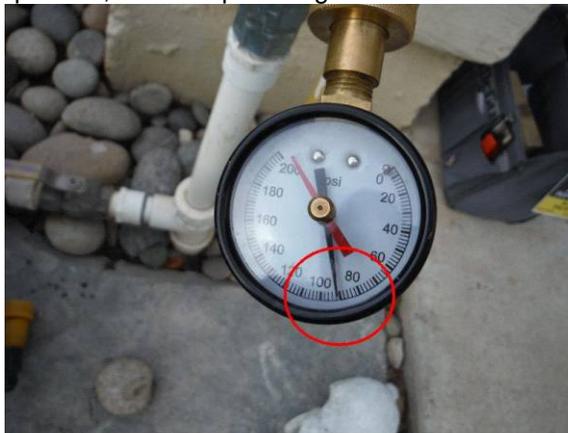
Pressure was tested in the morning. Water pressure appears to be approximately 90 to 95 psi. Water pressure above 80 psi. This water pressure is too high for residential buildings. Recommend adjustment or replacement of the pressure regulator by a qualified, licensed plumbing contractor.

**Water pressure is too high**

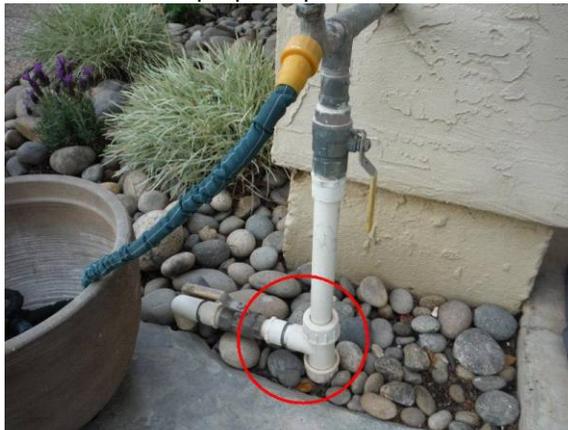
The visible portions of the main water supply line appears functional. Water shut off valve is installed, not tested. Compression tee visible on the main line before the shut-off valve. This is NOT recommended. A qualified, licensed plumbing contractor should be consulted for further evaluations and proper repairs as needed.

**Compression tee before shut off valve**

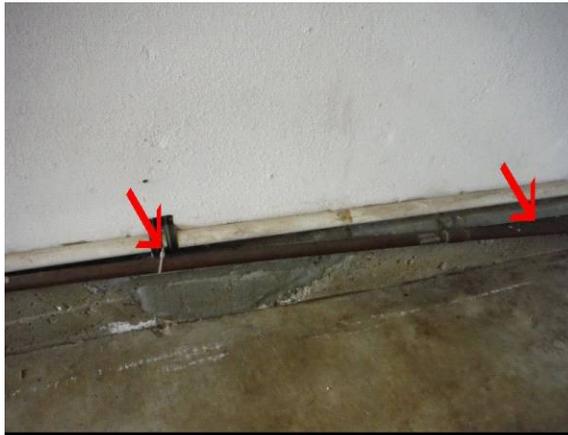
**MATERIAL:** Copper pipes.  
**CONDITION:** Visible portions of the supply plumbing system appears to be in functional condition. Functional water flow appears to be serviceable. Pipes lack proper support at walls in the garage area. Recommend properly securing all pipes. Recommend further evaluation and repair by a qualified, licensed plumbing contractor. Some lines are not fully visible for inspection. Conditions within inaccessible or concealed areas cannot be determined without intrusive investigation. Inspection is limited.

**Improperly supported lines**

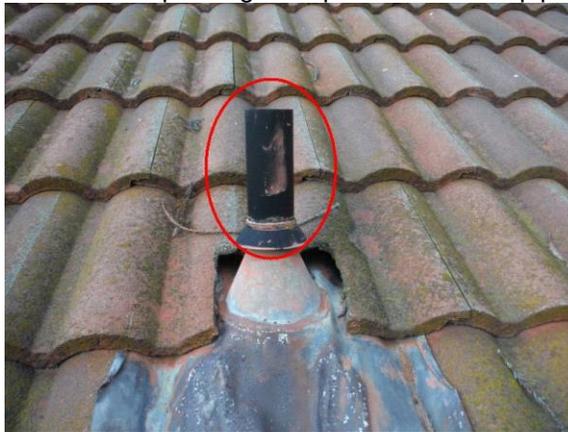
**ADDITIONAL NOTES:** Sewer lateral cleanout was located in the front yard at the time of the inspection. Recommend painting all exposed ABS vent pipes at roof to protect from UV light.

**Paint exposed ABS vent pipes**

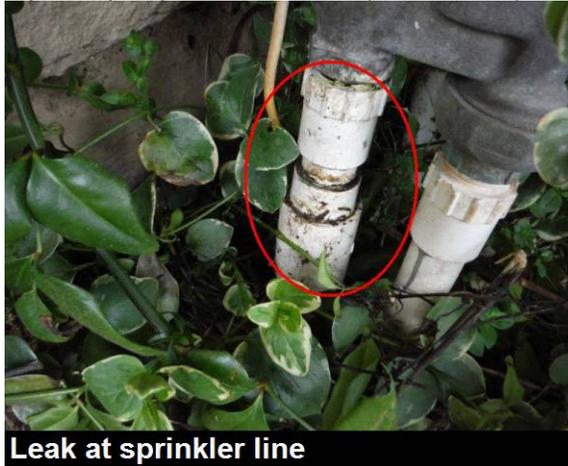
Active leakage was visible at sprinkler line(s) at the front yard. Recommend proper repairs by a qualified, licensed plumber or sprinkler fitter.

Leak at sprinkler line

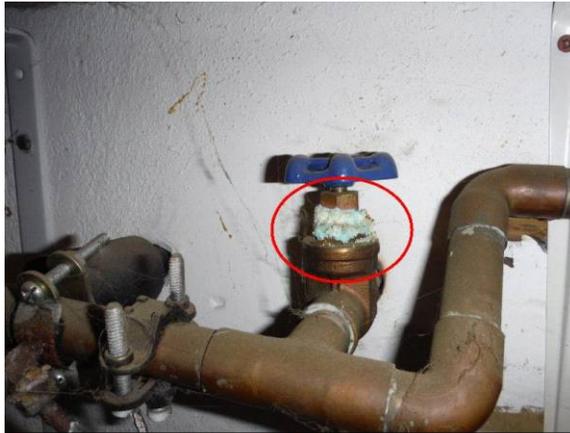
**Corrosion at shut off valve**

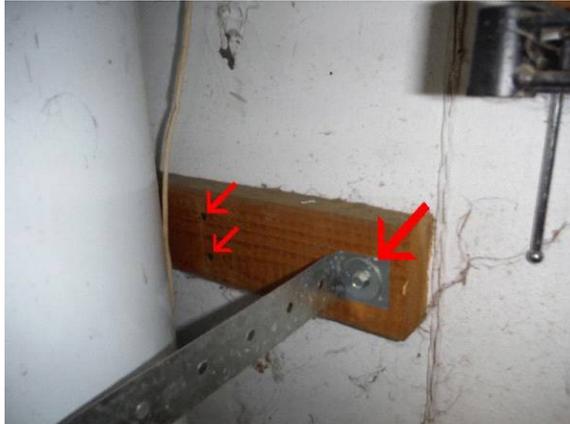
The visible portions of the vent pipe appear to be functional.  
Seismic straps are improperly installed. This condition is a potential SAFETY HAZARD, correction is needed. Straps appear to be installed on wood blocks at wall and not properly anchored to wall studs. Recommend further evaluation by a qualified, licensed contractor.

**Seismic straps attached to blocks**

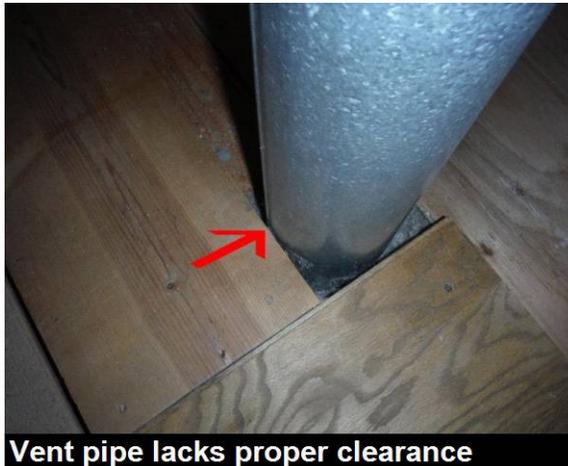
**GENERAL CONDITION:** System appears operational.  
**BURNERS/HEAT EXCHANGERS:** Serpentine type heat exchanger - Unable to fully inspect burn chamber. Burner flames appear typical. The heat exchanger portion of a gas fired heater is difficult to access without disassembly and cannot be adequately checked during a visual inspection.  
**VENTING:** The visible portions of the vent pipe and venting system(s) appears to be in functional condition. Induction fan was operational. Vent pipe has improper clearance to combustible materials at the attic area. This type of vent pipe requires a one inch clearance to combustible materials. Contact a qualified, licensed HVAC contractor for further evaluation and repairs as needed.

**Vent pipe lacks proper clearance**

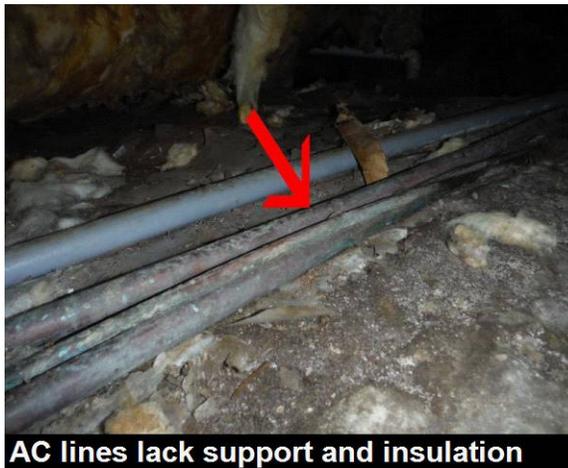
**REFRIGERANT LINES:** Appear functional. Refrigerant lines were missing insulation at some areas, recommend repair as needed for proper operation. Recommend properly supporting refrigerant lines at the crawlspace. Recommend further evaluation by a qualified, licensed HVAC contractor.

**AC lines lack support and insulation**

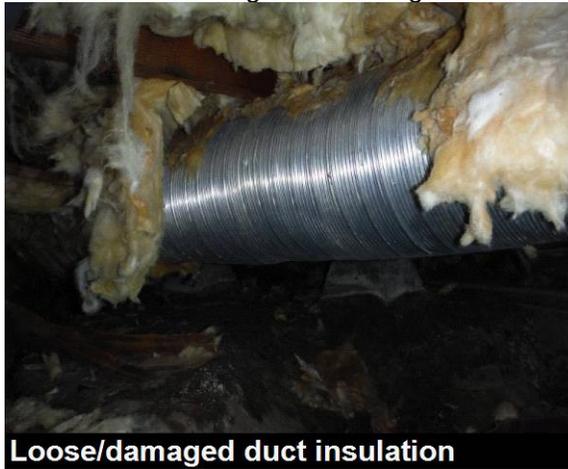
**Loose/damaged duct insulation**

Recommend cleaning and servicing entire duct system by a qualified professional.

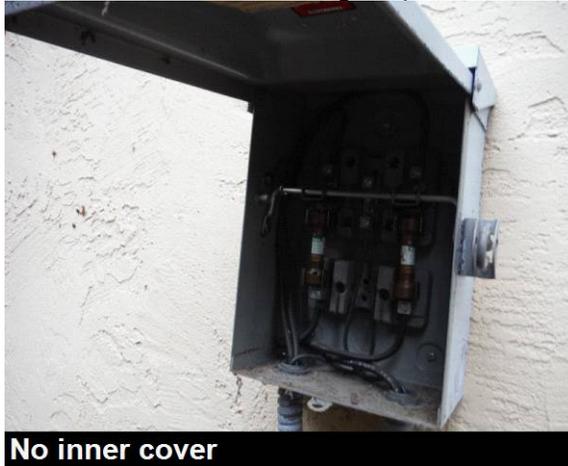
Disconnect panel does NOT have an inner cover. This is potentially hazardous to small children. Recommend locking the panel cover for safety enhancement.

**No inner cover**

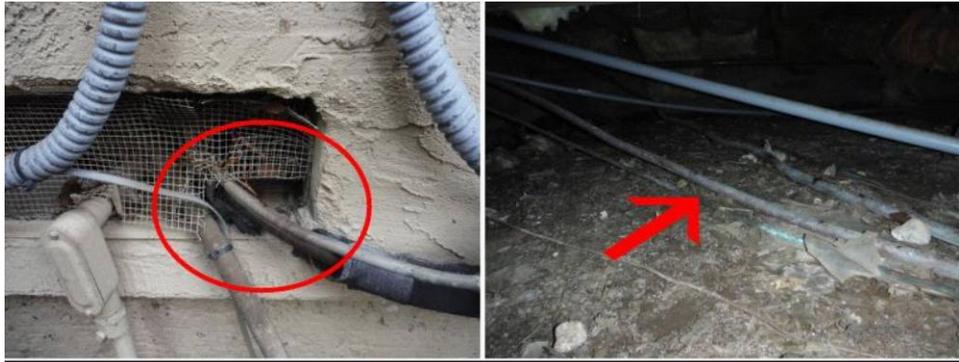
**Examples of noted conditions**

Recommend repairing all openings at crawlspace vent screen where air conditioner lines penetrate to prevent pest intrusion.

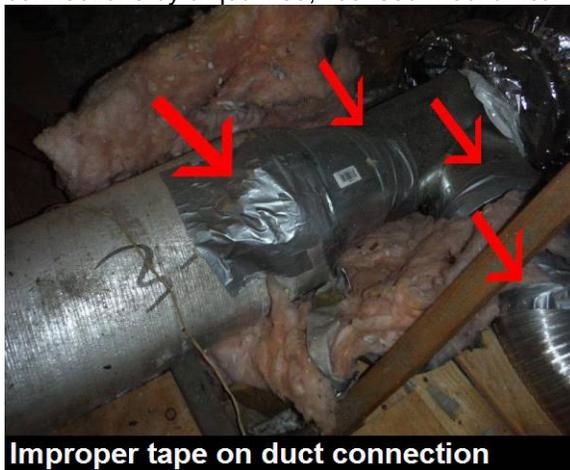
The visible portions of the duct system appears to be in functional condition. A number of dented/damaged ducts viewed. Conditions should be monitored, repair/replacement or adjustments may be necessary. Improper tape materials used at a number of areas. Recommend repair or replace with an approved tape or connection means at all duct connections by a qualified, licensed mechanical contractor.

**Improper tape on duct connection**

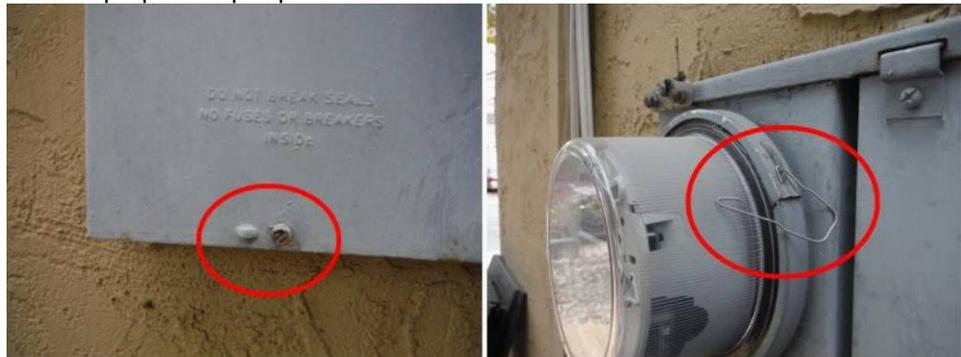
Underground type service wires are not visible for inspection. Ground conductor was present. Entire ground system was not fully visible for inspection. Utility seal is missing at service entrance side of panel. Utility seal is damaged/deteriorated at service meter. Recommend contacting the utility company to install a proper tamper-proof seals as needed.

Missing and damage seals

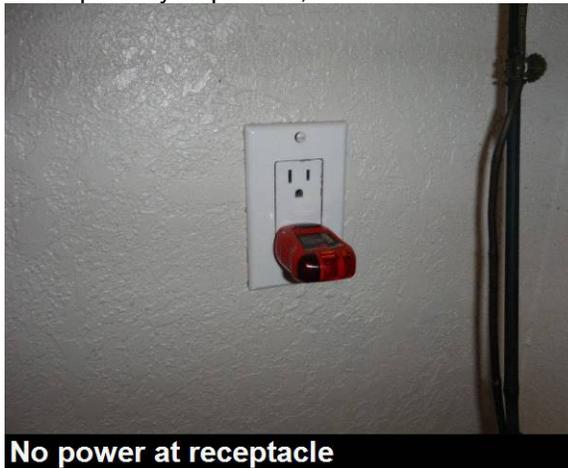
**RECEPTACLE OUTLETS:** A representative sampling of receptacle outlets was tested. Tested receptacle outlets throughout the house appear to be in functional condition. Furnishings and occupants belongings prevent testing of a number of receptacles. Receptacle did NOT function, no power at the master bathroom, far left receptacle. Recommend further evaluation and repairs by a qualified, licensed electrical contractor.

**No power at receptacle**

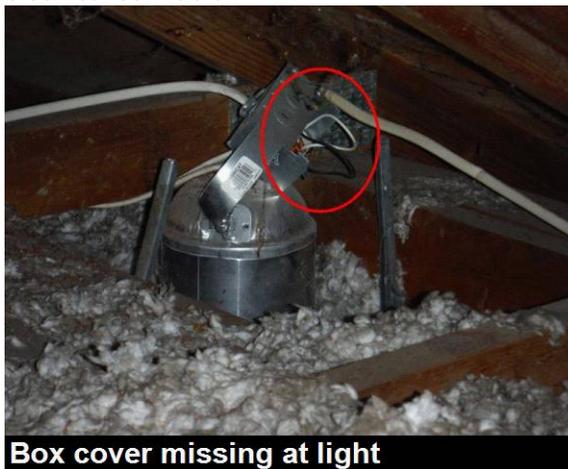
A representative sampling of lights and switches were tested. The general condition appears to be operational. Electrical junction box cover is missing at recessed light in the attic area, above the bathroom. All active electrical junction boxes need to be properly covered in case of overheating of electrical connections to help prevent the spread of fire. Recommend further evaluation and repairs by a qualified, licensed electrical contractor.

**Box cover missing at light**

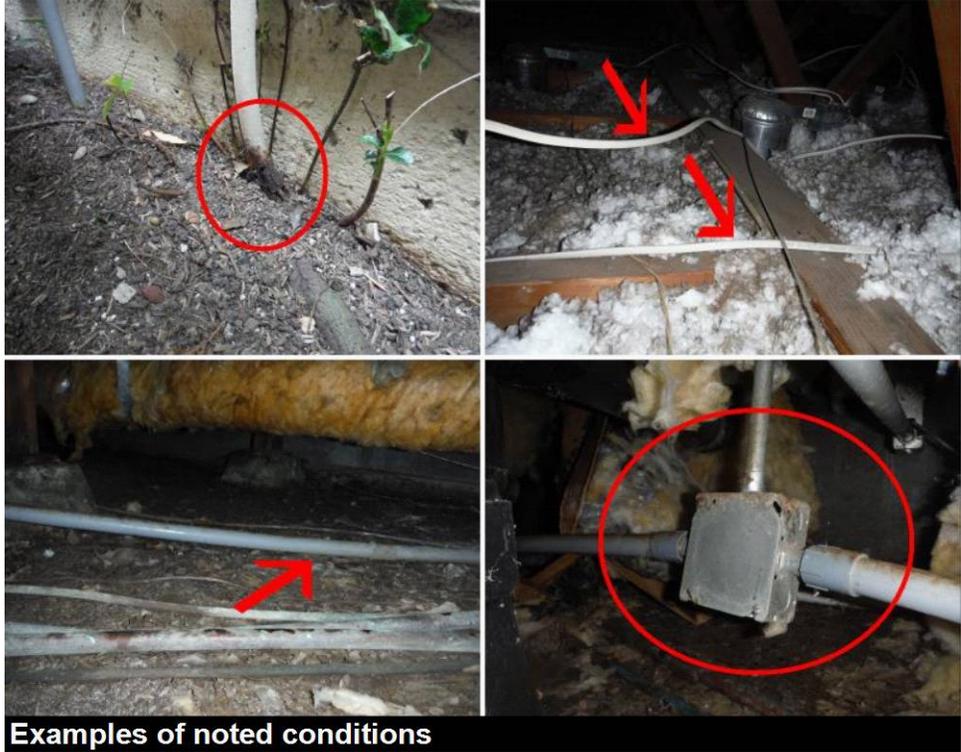
Examples of noted conditions

Rusted/damaged metal conduit at the exterior, under the main panel. Recommend loose, exposed non-metallic wiring be properly secured and protected from physical damage in the attic area. Wires and conduit needs to be properly secured in the crawlspace to ensure safe conditions. Electrical junction boxes need to be properly supported in the crawlspace. Junction boxes should not rely on electrical conduit for support. Repairs are recommend for safety enhancement. Recommend further evaluation and repairs by a qualified, licensed electrical contractor.

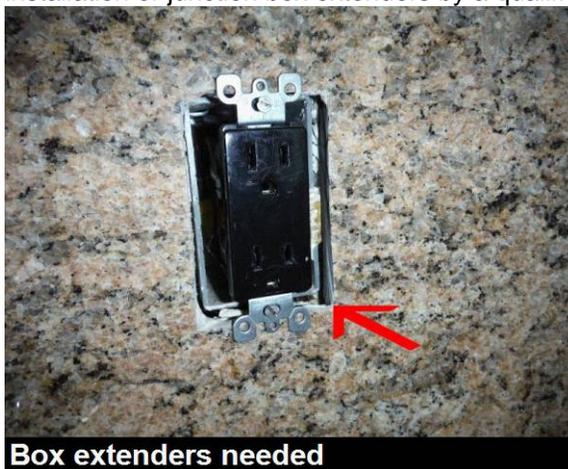
- Outlet receptacles are improperly installed at the countertop wall. Junction boxes need to be flush with outlet receptacles to ensure safe conditions. Recommend proper installation or junction box extenders by a qualified, licensed electrical contractor.

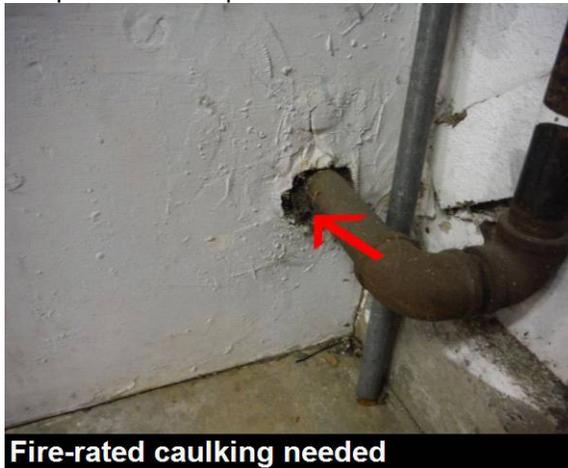
CONDITION: The general condition of the garage firewall separation between the house and the garage appears to be in functional condition. Recommend fire-rated caulking at any openings and/or protrusion in firewall/ceiling. Occupants belongings, cabinets, shelves and/or work benches installed obstruct view and prevent full inspection.

Fire-rated caulking needed

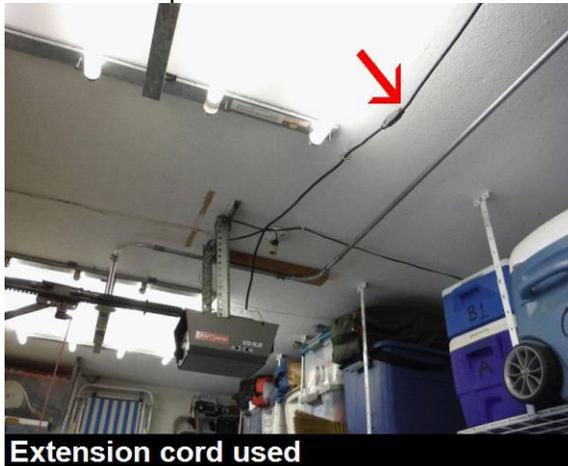
**AUTOMATIC OPENER CONDITION:** Automatic door opener is operational. Unit is powered by the use of an extension cord. This is a potential safety hazard. Correction is needed. Recommend repairs by a qualified, licensed electrician. Garage door opener light and light cover is missing or not installed at the time of the inspection. Manual release handle is present (not tested during this inspection). Automatic reverse feature did NOT respond to inspectors contact reversal test. This is a possible safety hazard and correction is needed. Door opener tension needs adjustment to insure safe conditions. Recommend evaluation and repair by a qualified / trained door system technician. Electronic eye sensors appeared operational at the time of the inspection.

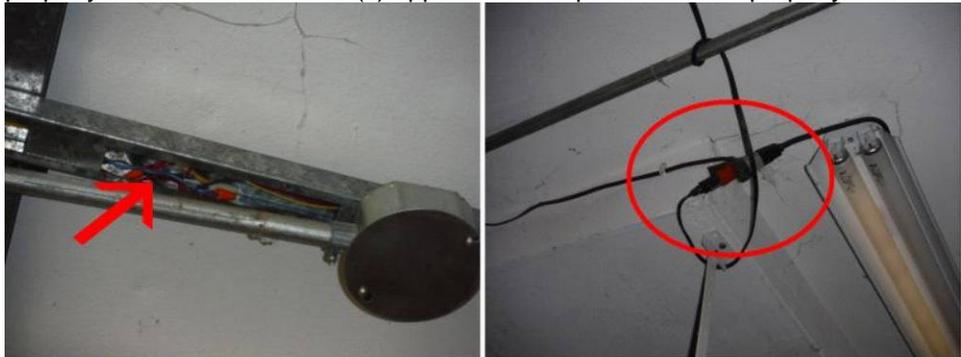
**Examples of noted conditions**

<b>CONDITION:</b>	Garage light(s) were operational at the time of the inspection. Light fixtures appear to be improperly wired, extension cords in use as permanent wiring. Light covers area missing/not installed at light fixture(s). Missing ballast covers at a number of areas. Recommend further evaluation and repairs by a qualified, licensed electrical contractor. Accessible outlet receptacles in the garage area were functional and appear to be properly wired. 240 volt outlet(s) appears to be operational and properly wired.
-------------------	---------------------------------------------------------------------------------------------------------------------------------------------------------------------------------------------------------------------------------------------------------------------------------------------------------------------------------------------------------------------------------------------------------------------------------------------------------------------------------------------------------------------------------
